EPA Region 9

Technical Memorandum: <u>Investigation</u> of <u>Abandoned</u> Wells on Navajo Nation

Eastern Research Group, Inc.

Revision No. 1 [DATE \@ "MMMM d, yyyy"]

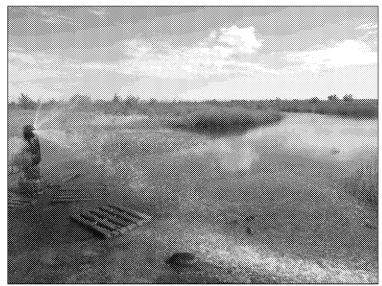
Photograph 1. The Foshay well (NM-001), located approximately 55 miles northeast of Gallup, NM.

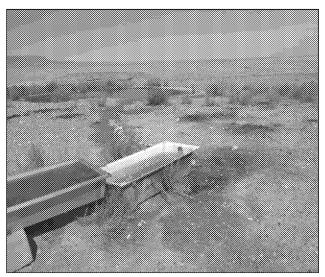
Photograph 2: Example of a well (NM-003) where well water was re-routed. The sampling team interviewed a local land owner who stated they used the water for drinking water and for livestock.
